### Pier E3 Demonstration Project Area

### Pier E3

THE SAN FRANCISCO-OAKLAND BAY BRIDGE EAST SPAN SEISMIC SAFETY PROJECT

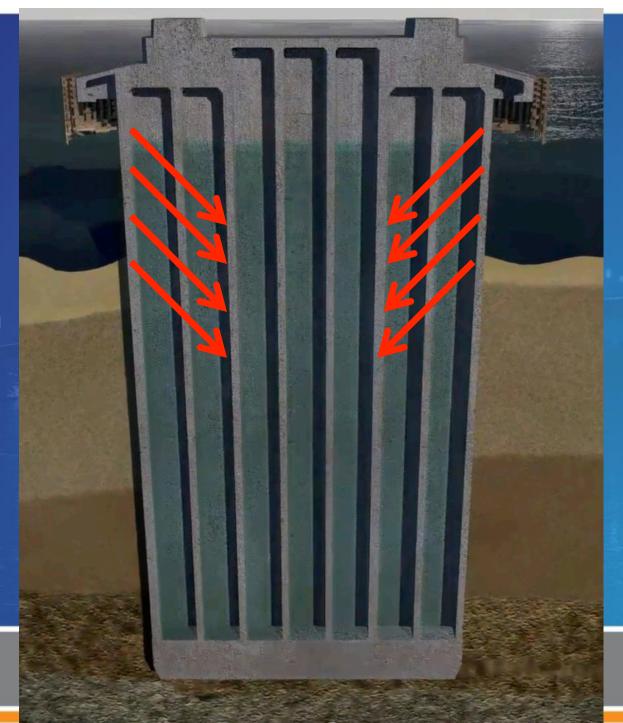
All rubble was disposed in-situ below removal elevation.

Per BCDC
Permit
2001.008.38
Authorization
I-A-5-h

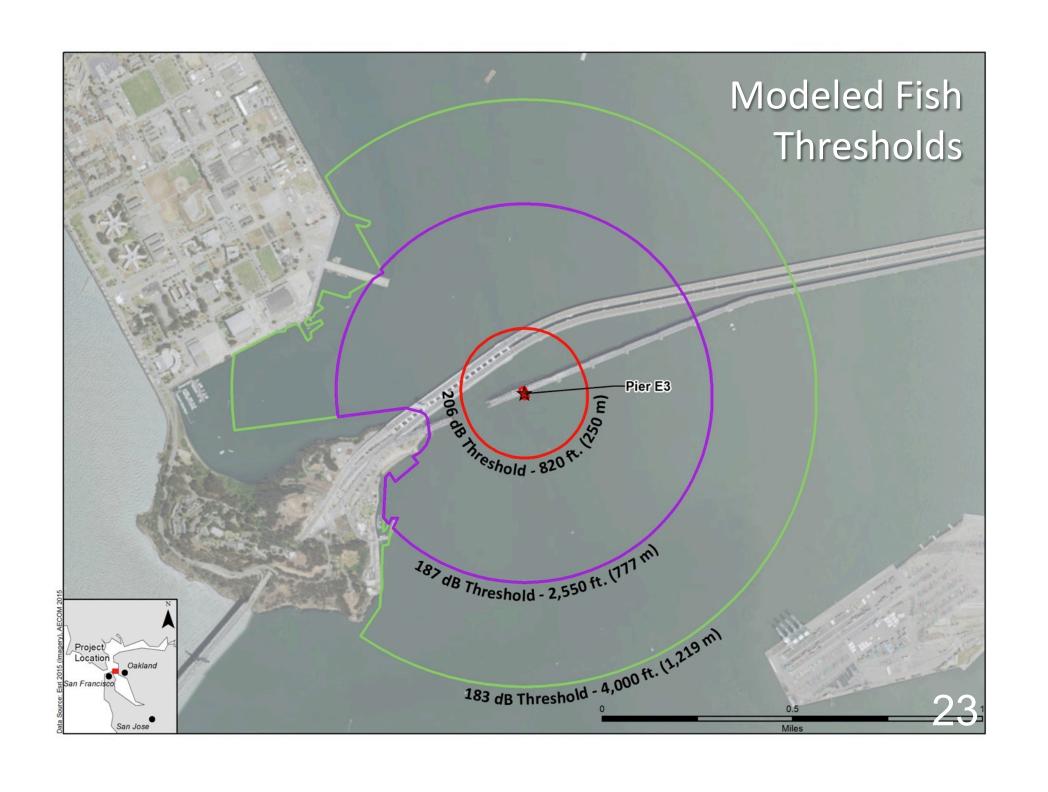
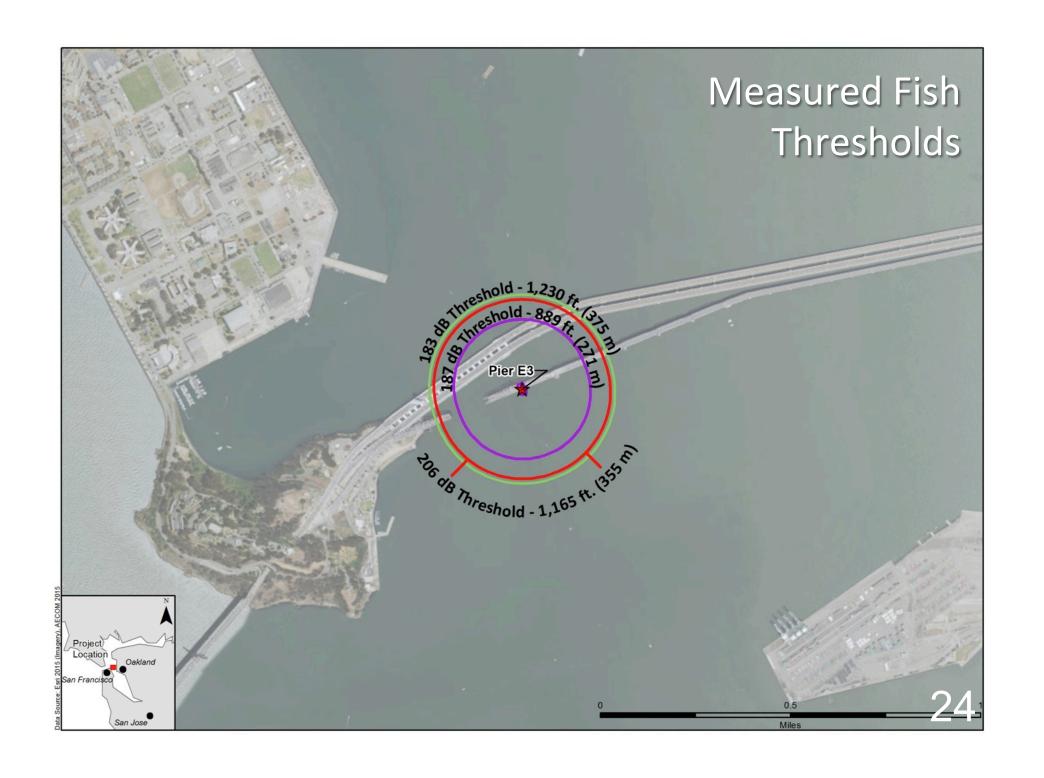
# Modeled vs. Measured Distances to NMFS Fish Threshold Criteria

Criteria	Threshold	Modeled Distance (feet)	Measured Distance (feet)			
Peak Pressure	206 dB	820	1,165			
Cumulative SEL ≥ 2g	187 dB	2,550	889			
Cumulative SEL < 2g	183 dB	4,000	1,230			
RMS Sound Pressure Level	150 dB	68,000	4,752

dB – decibel; SEL – sound exposure level; RMS – root mean square (fish behavioral threshold); g – gram Note: The BAS measured an ~80 percent efficiency in acoustic attenuation based on data from the implosion. Source: I&R 2015

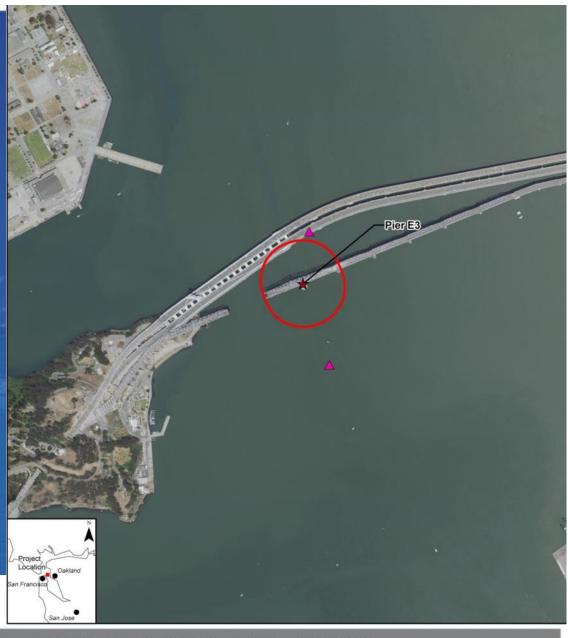
### Bird Monitoring

No diving birds were observed in the 500-foot Watch Zone just prior to implosion

500 ft. Avian Watch Zone (152 m)

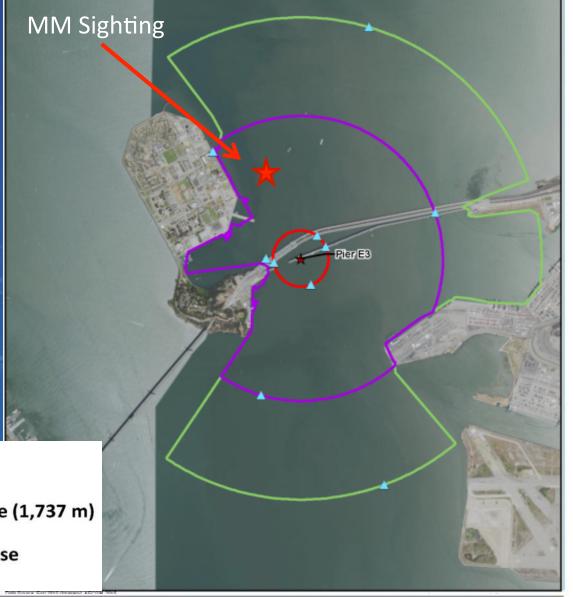
# Marine Mammal Monitoring

1 harbor seal observed ~4500′ from Pier E3 seen >30 min prior to implosion

5,700 ft. Elephant Seal Exclusion Zone (1,737 m)

9,700 ft. Pinniped Behavioral Response Monitoring Zone (2,957 m)

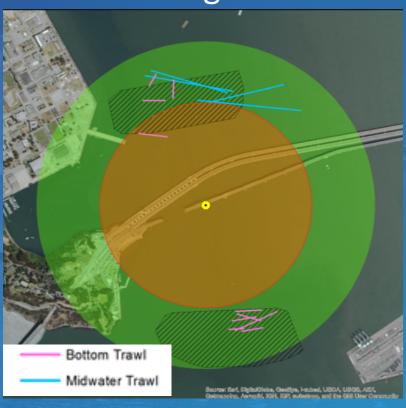
**Trawling Lanes**

- 1,229 fish collected in 14 trawls
  - 1,158 collected alive(94.2%) and 71collected dead (5.8%)
  - No longfin smelt,
     salmonids, or green
     sturgeon collected

Trawling required by CDFW ITP

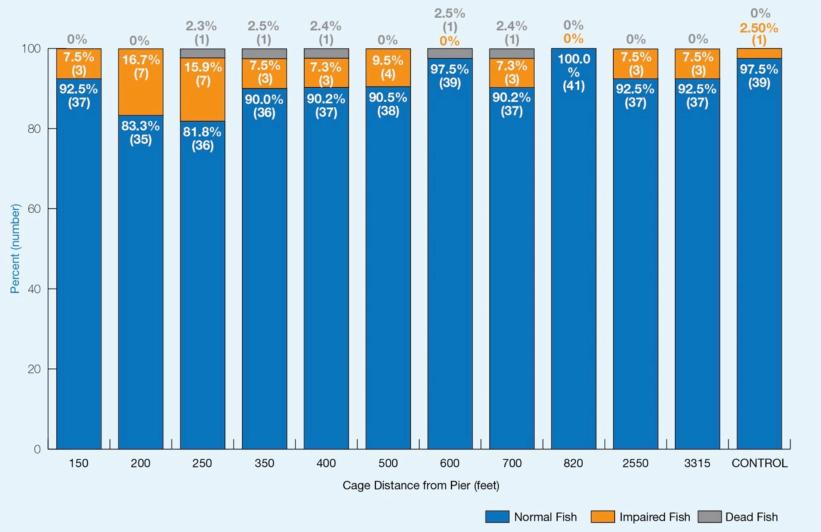
### Caged Fish Study Results

Caged Fish Study - Individual Cage Results - Pier E3 Demolition												
Cage ID	150	200	250	350	400	500	600	700	820	2550	4000	Control
Distance from E3 (m)	45.7	61.0	76.2	106.7	121.9	152.4	182.9	213.4	249.9	777.2	1,010.4	777.2
Distance from E3 (ft)	150	200	250	350	400	500	600	700	820	2,550	3,315	2,550
Fish Exposed (count)	40	42	44	40	41	42	40	41	41	40	40	40
Dead (count)	0	0	1	1	1	0	1	1	0	0	0	0
Dead (%)	0.0%	0.0%	2.3%	2.5%	2.4%	0.0%	2.5%	2.4%	0.0%	0.0%	0.0%	0.0%
Impaired (count)	3	7	7	3	3	4	0	3	0	3	3	1
Impaired (%)	7.5%	16.7%	15.9%	7.5%	7.3%	9.5%	0.0%	7.3%	0.0%	7.5%	7.5%	2.5%
Total Impaired or Dead (Count)	3	7	8	4	4	4	1	4	0	3	3	1
Total Impaired or Dead (%)	7.5%	16.7%	18.2%	10.0%	9.8%	9.5%	2.5%	9.8%	0.0%	7.5%	7.5%	2.5%
Normal (count)	37	35	36	36	37	38	39	37	41	37	37	39
Normal (%)	92.5%	83.3%	81.8%	90.0%	90.2%	90.5%	97.5%	90.2%	100.0%	92.5%	92.5%	97.5%

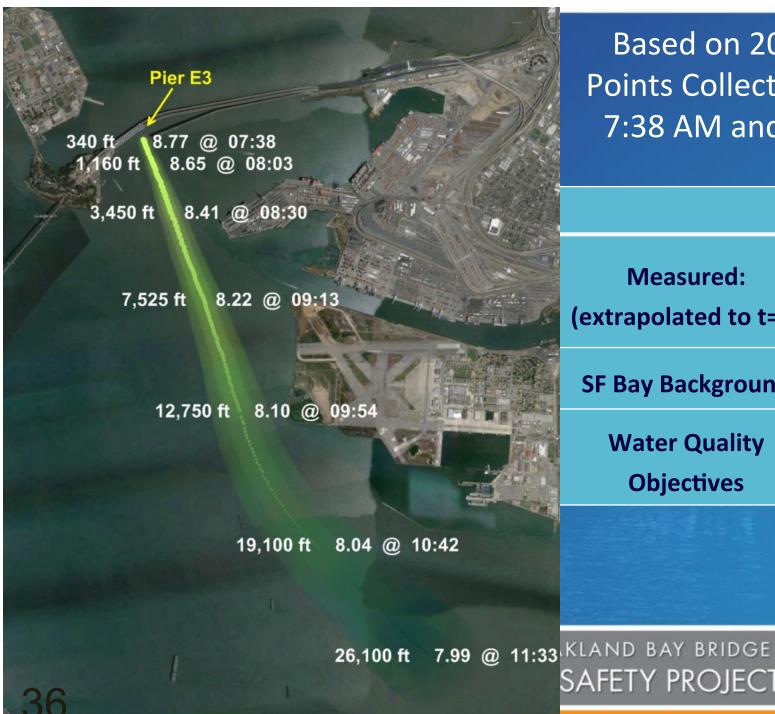
### Based on 20,000 Data Points Collected Between 7:38 AM and 11:33 AM

рН
Measured: (extrapolated to t=0)	9.0
SF Bay Background	8.0
Water Quality Objectives	6.5 to 8.5; or $\Delta$ 0.5 from background

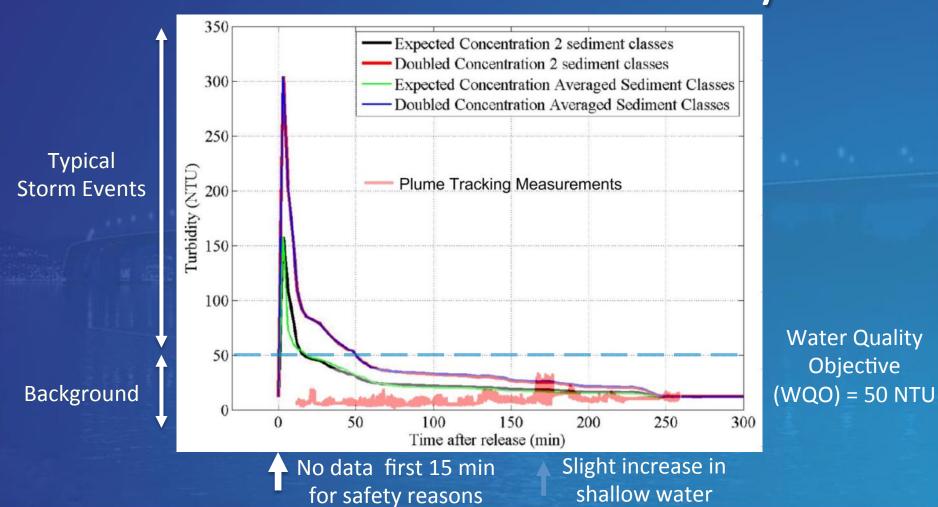
### Sondes Measure Turbidity

- No Detectable Change In Turbidity Observed
- pH (1 Hour Post Blast) Was Elevated Above the Background pH of 8.0, Was Less Than a 0.5 pH Unit Increase

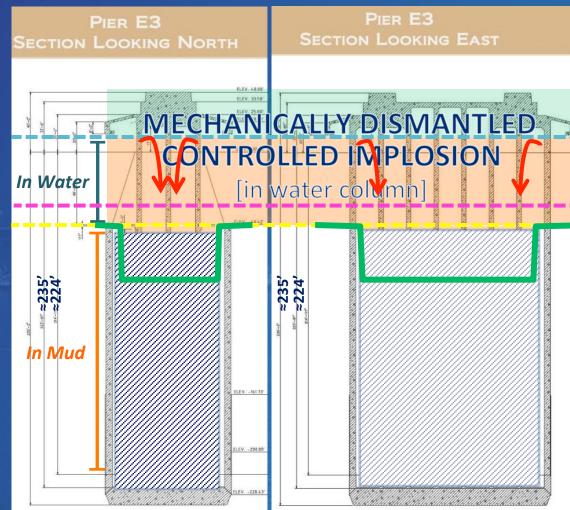
### Depth/Elevation of Removal

**Scoured Mudline &**

All rubble was

Removal Elevation [-51']

disposed in-situ below

removal elevation.

MHW +1.5

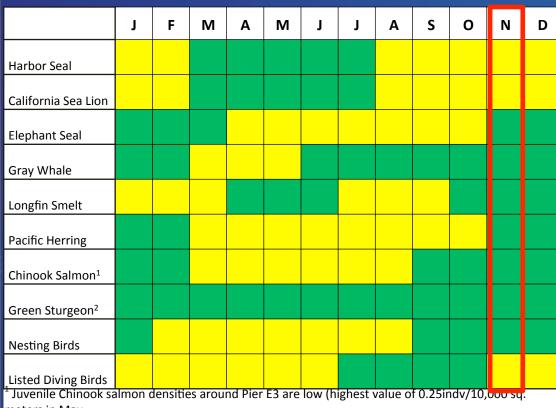
### Implosion Scheduled for November

Optimal times for Pier E3 blast based on presence of biological resources.

Green boxes are months when species were not expected around Pier E3 or at low densities.

<sup>&</sup>lt;sup>2</sup> Green sturgeon have potential to occur around Pier E3 year-round, but in very low densities

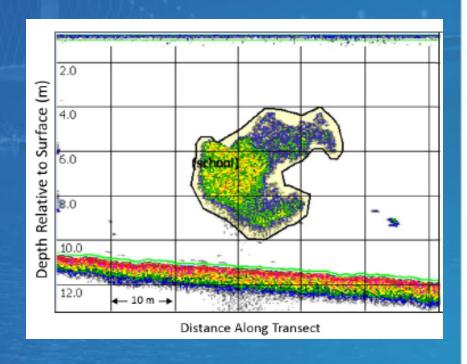
## Fisheries Monitoring – Sonar Assessment

- Fish distribution was similar between north and south areas
- Length mode of individual fish
   ~ 2.5 inches
- Most targets were less than 4 inches in size
- Densities somewhat high in the south area

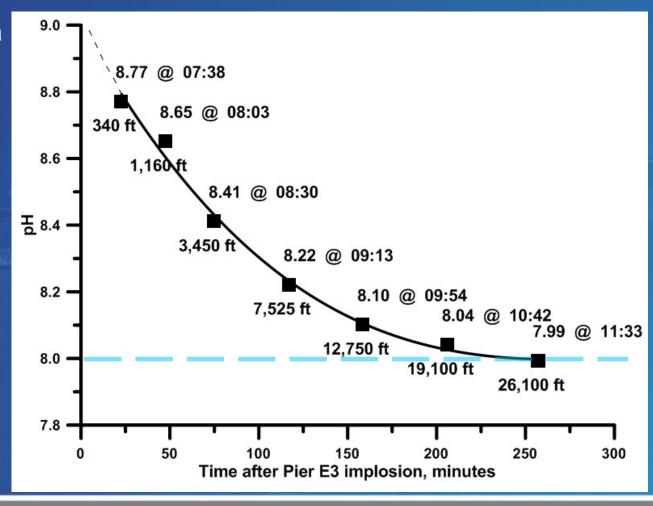
### Sondes Measure pH

Based on 20,000 data points collected over plume from 7:38 AM until 11:33 AM

Extrapolate to t=0

SF Bay Background pH level = 8.0

- pH Returned to Background Conditions in ~4hrs
- Metals Concentrations Were Comparable to RMP
- Metals Concentrations Were Below Water Quality Objectives
- Final Sediment Results Are Pending Lab Analyses

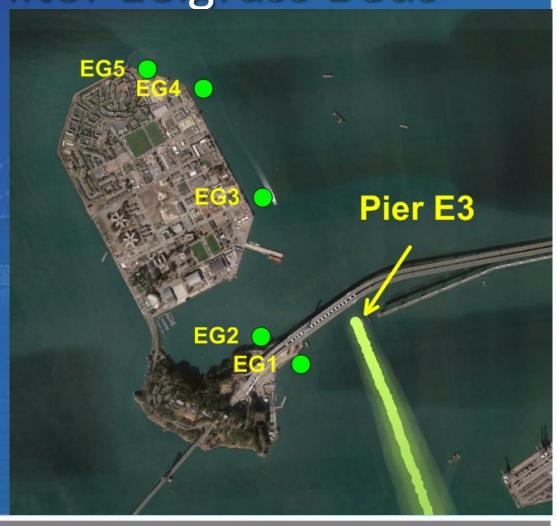
### Sondes Monitor Eelgrass Beds

- Prediction Was No Impact to Eelgrass Beds
- 5 Buoys Deployed to Monitor pH and Turbidity
- Monitoring Detected No Changes to Water Quality
- Plume Moved Away
   From Eelgrass Beds
   Because of Flood Tide

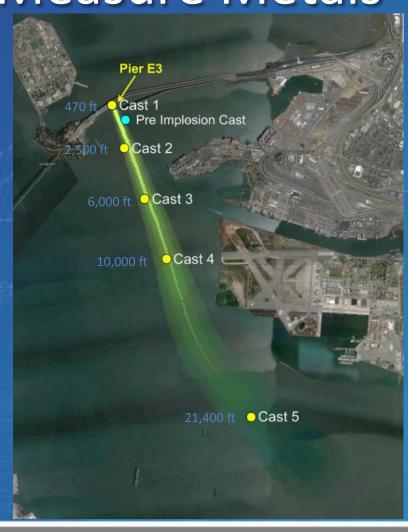
### Grabs Help Measure Metals

- Metals Measured: Cadmium, Chromium, Copper, Zinc, and Lead
- Results Comparable to Ambient Established by Regional Monitoring Program (RMP)
- No Exceedances of Water Quality Objectives

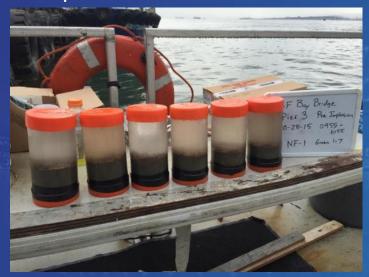
# Sediment Sampling Tests Benthic Habitat Quality

Pre-implosion Sediment Sampling Completed

Results Indicate Some Pre-implosion Toxicity, Comparable to RMP

Post-implosion Sediment Sample Results Pending

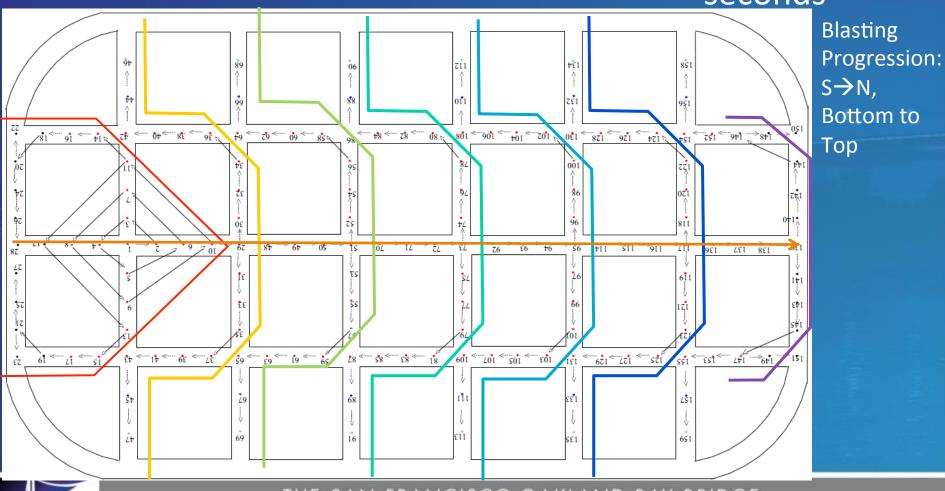
#### Blast Plan

- 588 Controlled Charges
  - Completed in 5.3 seconds
